Figure 2-14
Mile 92 Crow Canyon

Integrated USIBWC Land Management Alternative

Targeted River Restoration Alternative

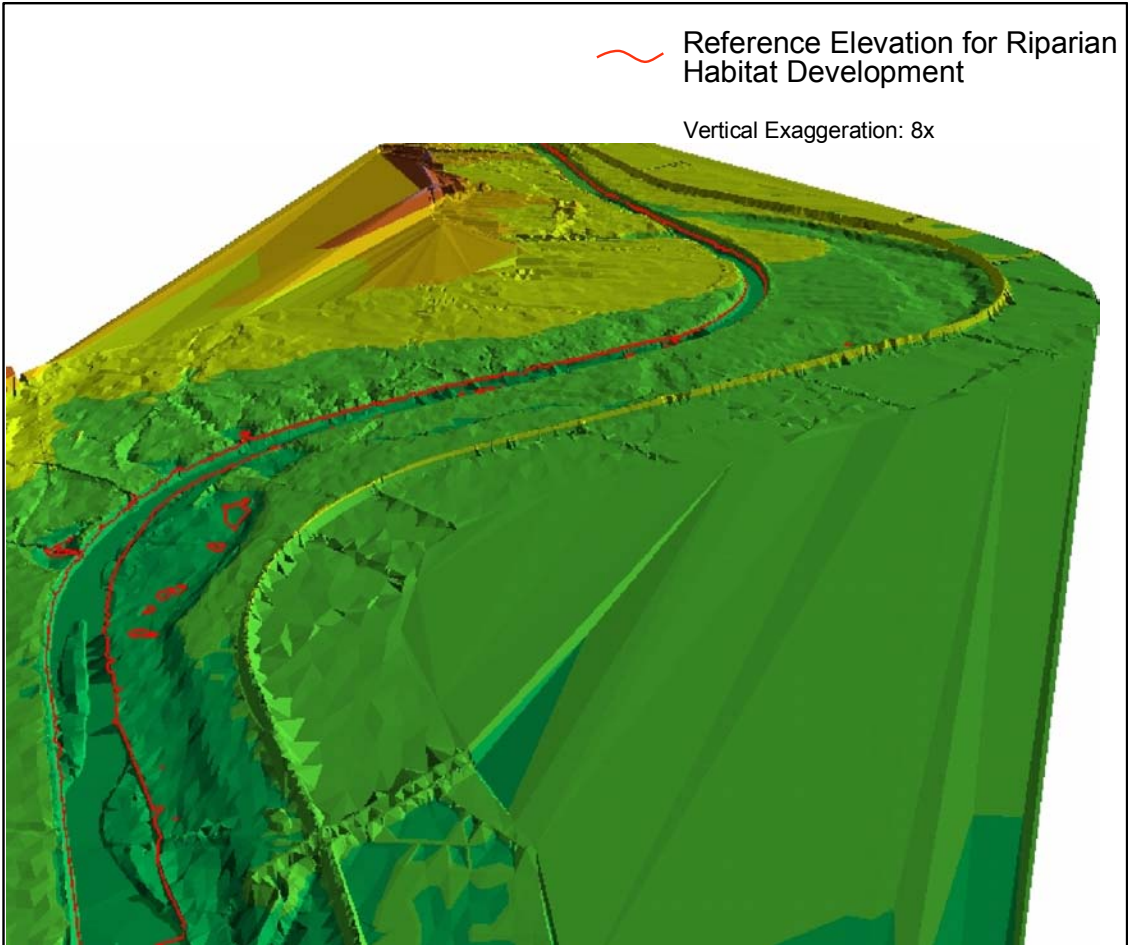
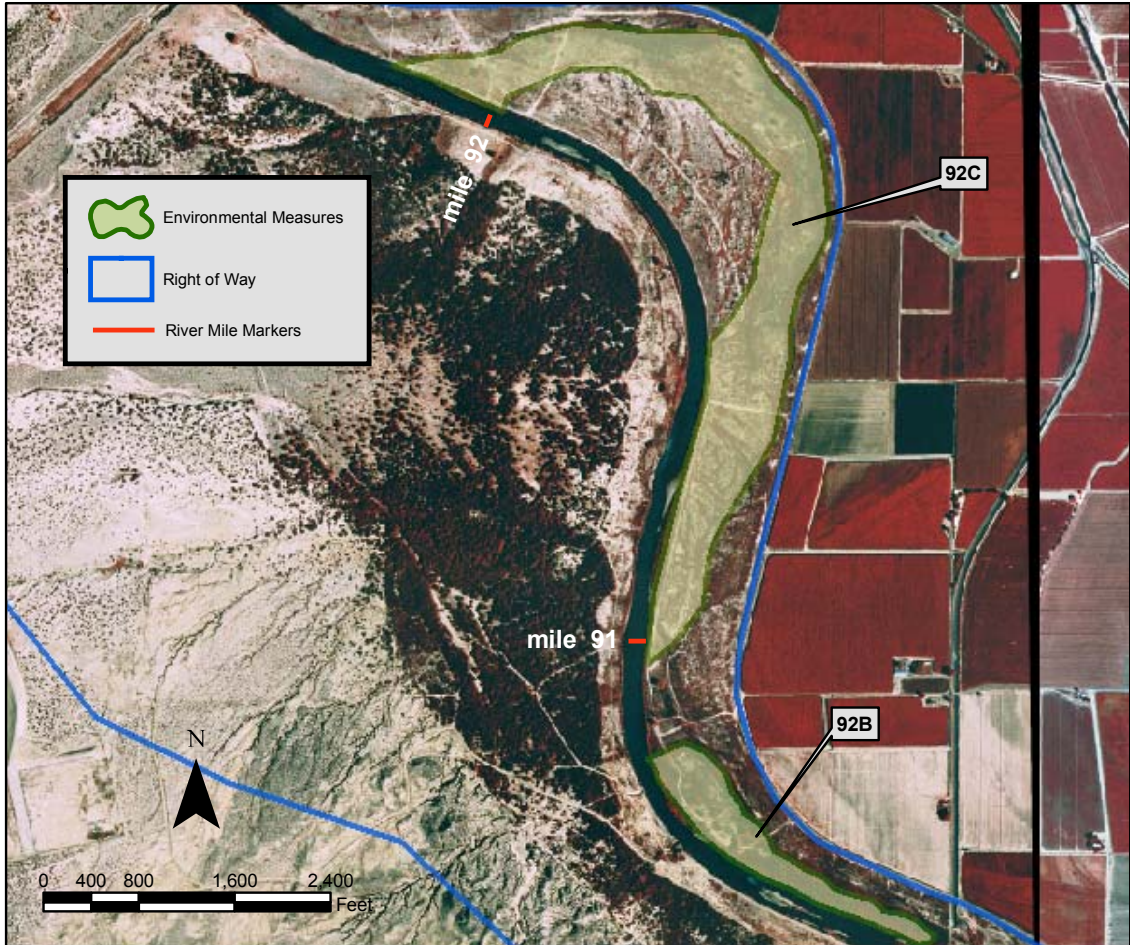
The majority of the bosque was cleared during RGCP construction and is now dominated by herbaceous vegetation and salt cedar. A straight, stepped channel extends from Crow Canyon dam to the west side of the river channel south of mile 93. The ROW on the west side of the river abuts land owned by BLM. A large area of ROW on the eastern side of the river is mowed but not grazed. A few mature and young cottonwoods are growing in this area. Isolated areas contain wetland vegetation indicating a high water table.

Point Project Measures	ID	#	Area (ac)
Bank shave downs*	92B	1	17.9

Point Project Measures	ID	#	Area (ac)
Open former meander**	92C	1	84.6

* Bank shave downs acreage is included in the Targeted River Restoration Alternative as a linear measure "Seasonal peak flows".

* * The meander is outside the hydrologic floodplain but considered a potential measure due to relative elevation. However, due to elevation, not considered a location for planting measures (Alternative 3)
